Polyflex Alcan Aluminium Mine (Rio Tinto)

Owner	Alcan Aluminium Company (Rio Tinto)
Project	Protective coating and waterproofing crushing machinery
Contractor	Polymère MC2
Date of project	2008
Substrate	Steel
System:	
Surface preparation	Sandblast
Primer	MCU Primer
Topcoat	Polyflex 402

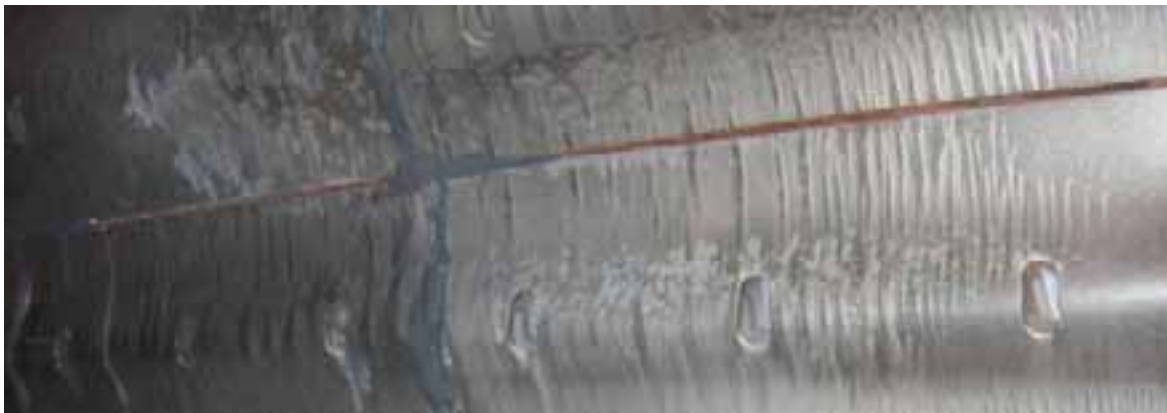
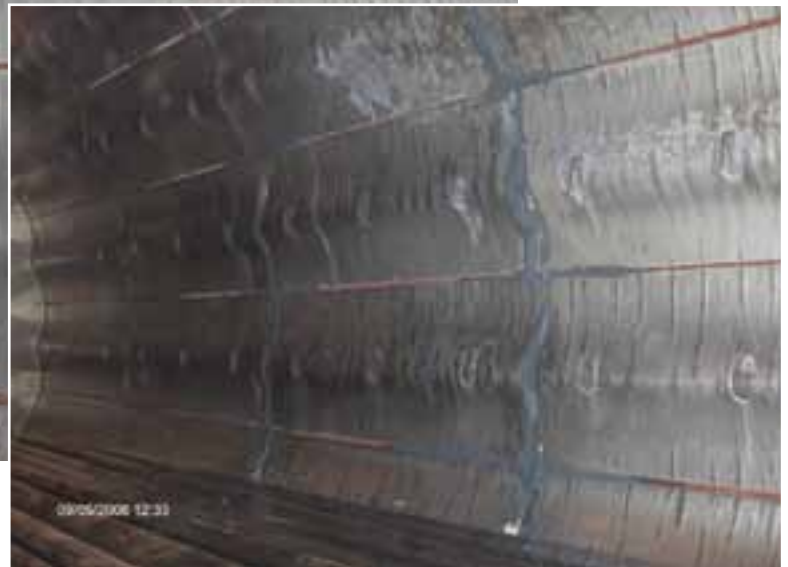
In this instance, the company was experiencing significant deterioration of rubber joints in machinery used in crushing various ores being processed.

Along with mechanical crushing, Sodium Hydroxide is used to help dissolve the material.

This caustic solution was causing damage to protective plates along the wall of the machine.

Replacing plates is a major operation requiring complete shut down for a period of seventeen days. This application of Polyflex 402 was completed in two days and provided protection

against the purifying solutions that are applied in temperature of 90° C.

Polyflex 402 has performed well in these extremely severe conditions.
