## Polyflex Rail Car Lining

**Project** Interior lining of rail car

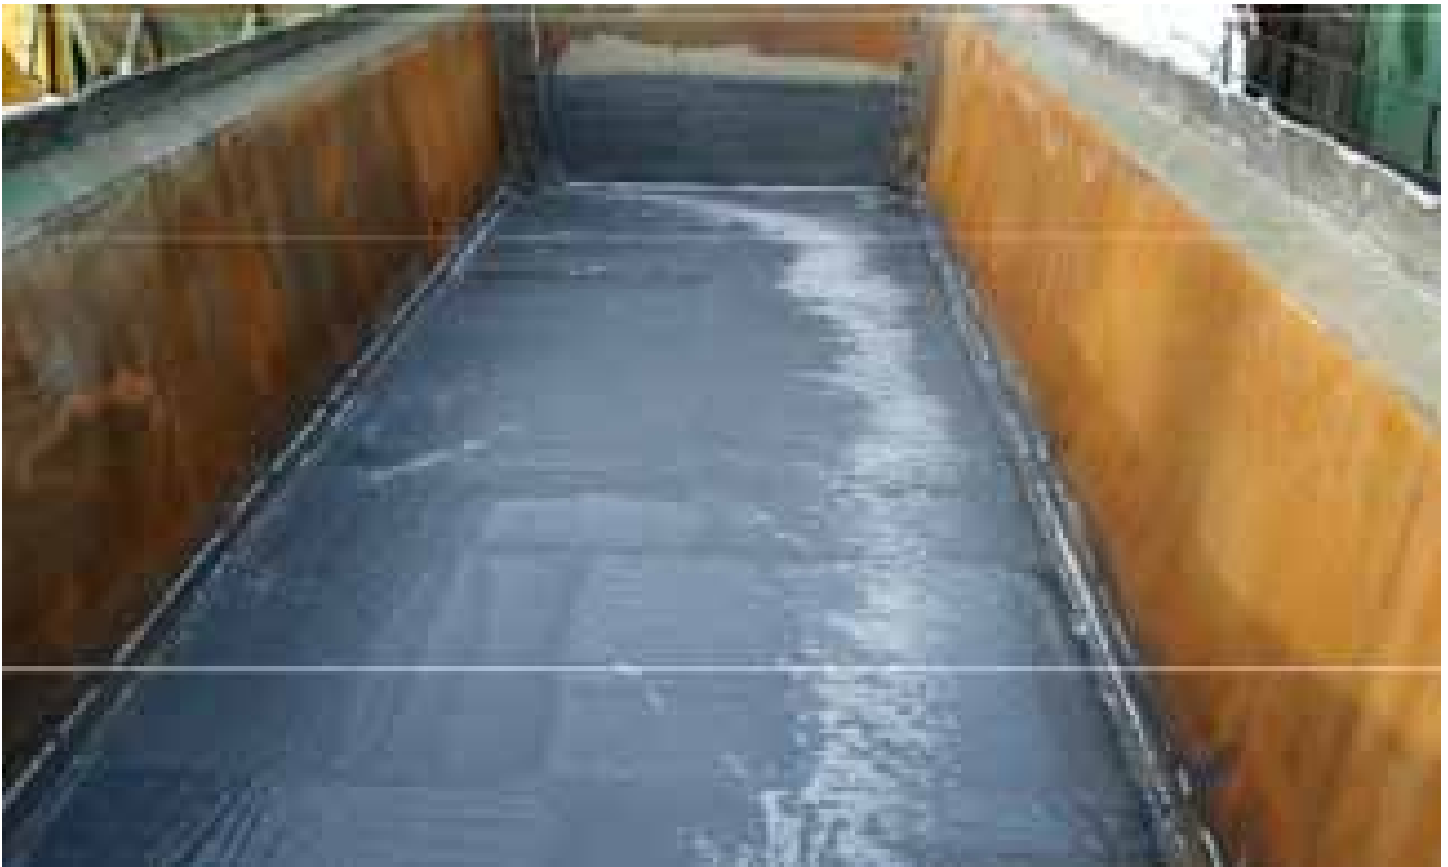
A metal products company was experiencing serious problems maintaining rail cargo cars that were used to transport rocks and metals to and from the various processing stages.

Main concerns centred around damage caused by impact during loading, abrasion

caused during loading and unloading as well as some corrosion damage.

In addition, as much as 5% of the material remained in the car after unloading resulting in additional cost and time delays.

Polyflex system of MCU primer coated with

Polyflex 201 provided a seamless membrane that is impact-, corrosion-, and abrasion-resistant and to which the metal pieces and dust do not adhere during unloading.

Polyflex 201 has provided an effective and cost efficient solution.
