Polyflex Pulp tank

Project Interior pulp tank coating

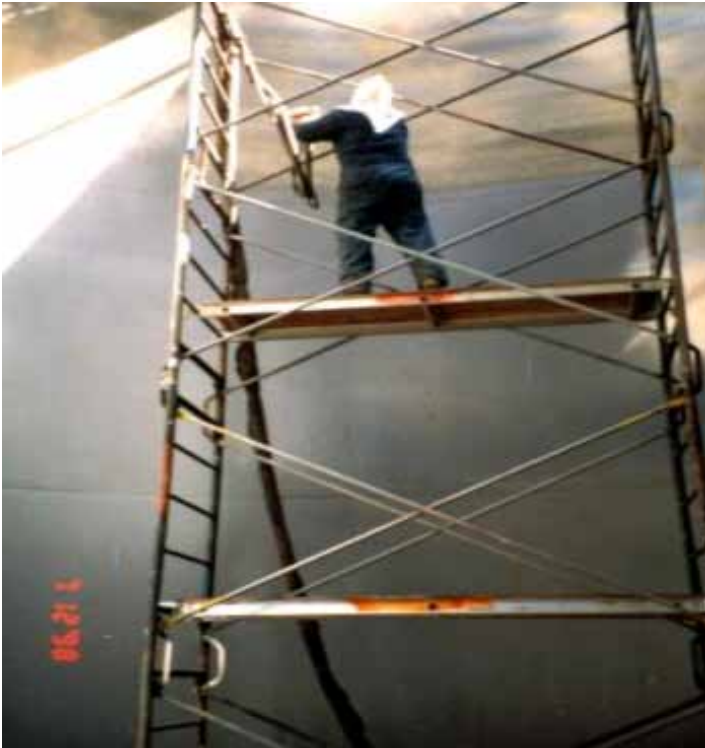
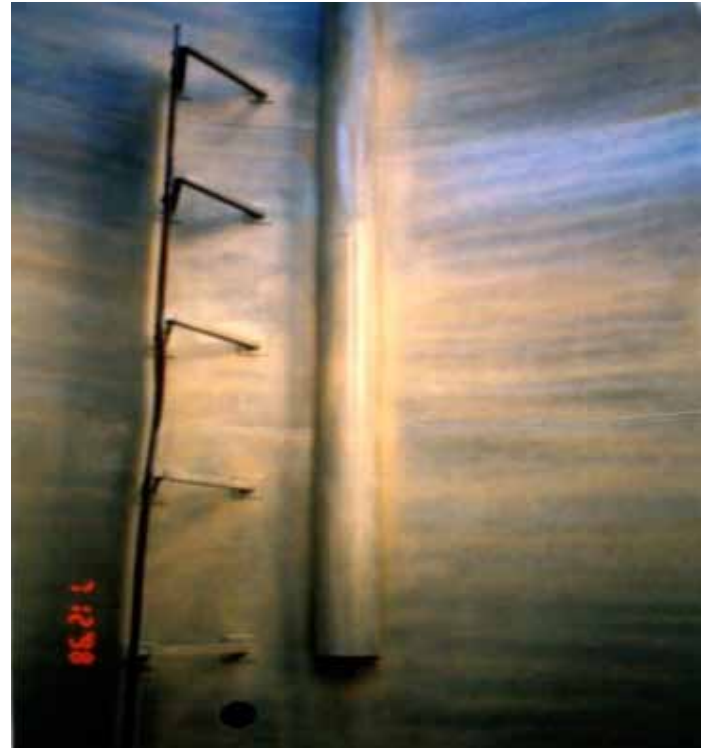
Pulp used in various mining processes can result in a very aggressive environment in contact with steel tank interiors.

Corrosion poses expensive problems especially around ladder and joint areas.

Polyflex 201 has been used successfully in

such applications to provide a seamless protective coating resisting corrosion, abrasion and leaks.

Substrate Steel

Surface preparation Sandblast

Primer MCU Primer

Topcoat Polyflex 201
